## **7.2.5 c - Energy review to identify areas where energy wastage is highest (Audit Report)**

# DESIGN VALIDATION & PROPOSAL

## AC FOR AUDITORIUM

## CRESCENT INSTITUTE OF SCIENCE & TECHNOLOGY GST Rd, Vandalur, Tamil Nadu 603210

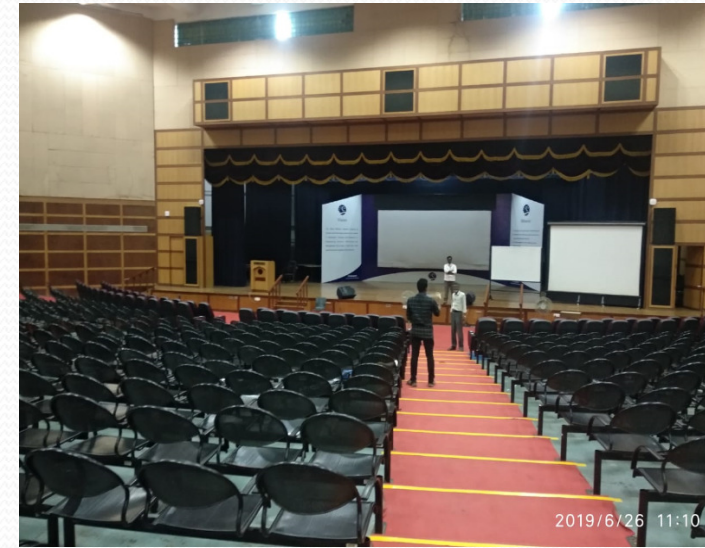
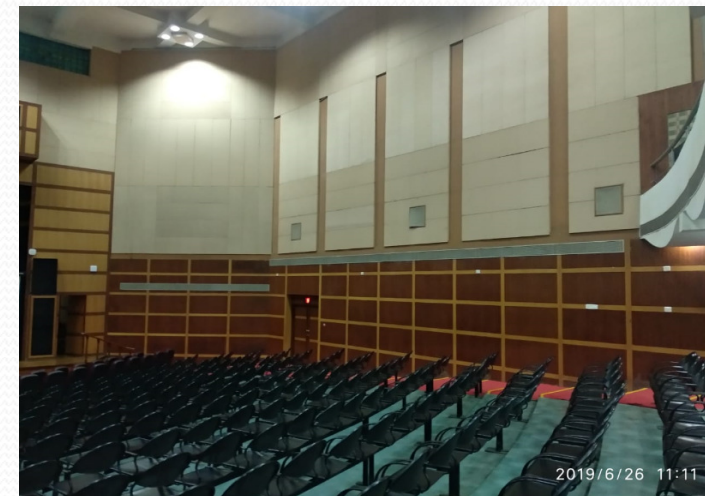
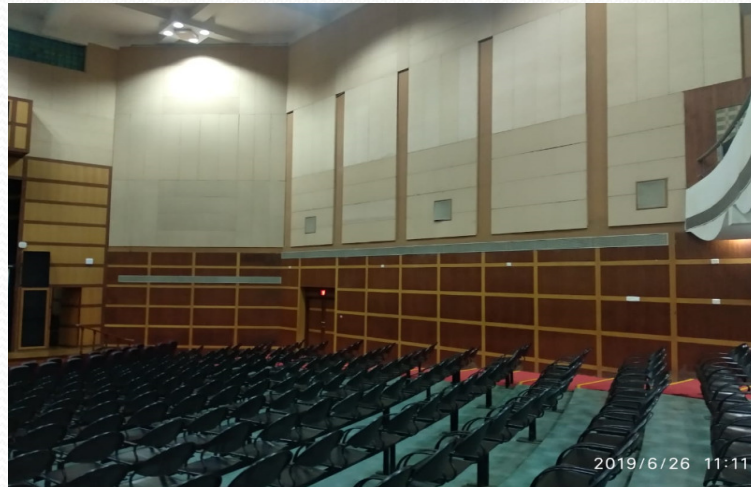
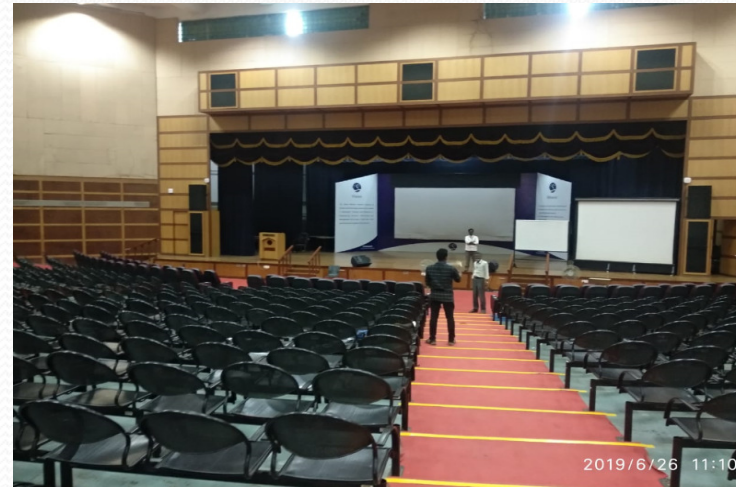
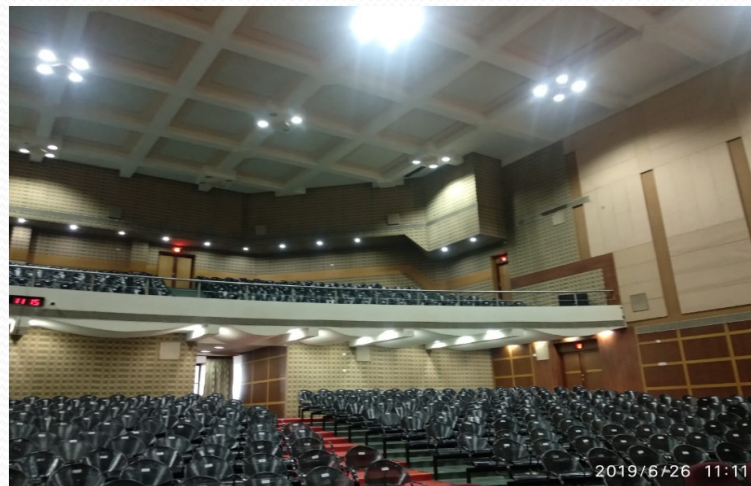
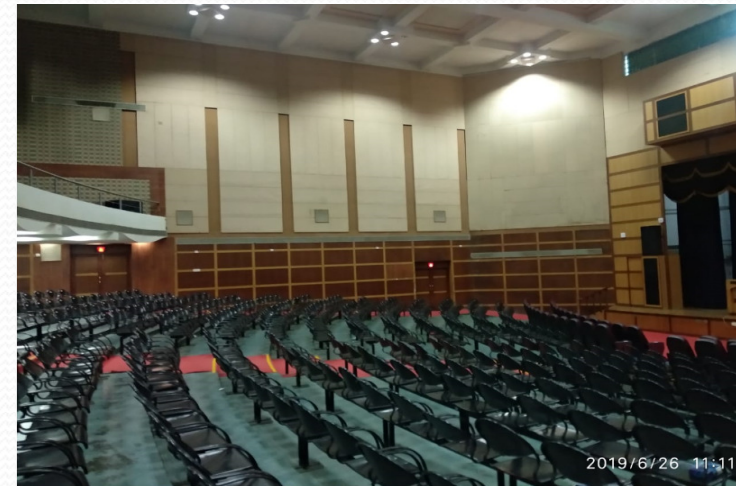
## **Present condition of Site condition:**

- After switching on all the equipment at Unload conditions the return air temperature at seating area is measured as 26°C & Supply Air Grille Temperature is 24°C instead of maximum of 12-13°C after two hours of switching on the Chilled water system.
- There is no change in the temperature at stage.

## **Action to be taken:**

- Corrective measures to be taken as indicated below for AHU and chilled water equipment.
- All ducting and equipment serving the stage area has to be replaced.

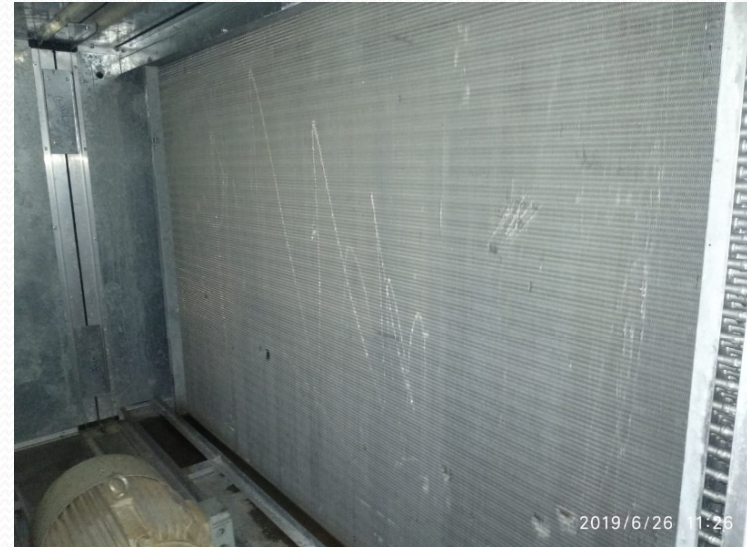
### **Present condition of AHU Coil:**

- As per Present site installation Chilled water inlet and outlet temperature are  $10.3^{\circ}\text{C}$  &  $12^{\circ}\text{C}$  respectively, instead of  $6^{\circ}\text{C}$  and  $11^{\circ}\text{C}$ , because of this there is not heat transfer being carried out.
- Present coil is fully covered with fungus and because of this no water is flowing properly.

### **Action to be taken:**

- AHU coil to be replaced with new coil and coil inlet and outlet temperature to be maintained as  $6^{\circ}\text{C}$  inlet and  $11^{\circ}\text{C}$

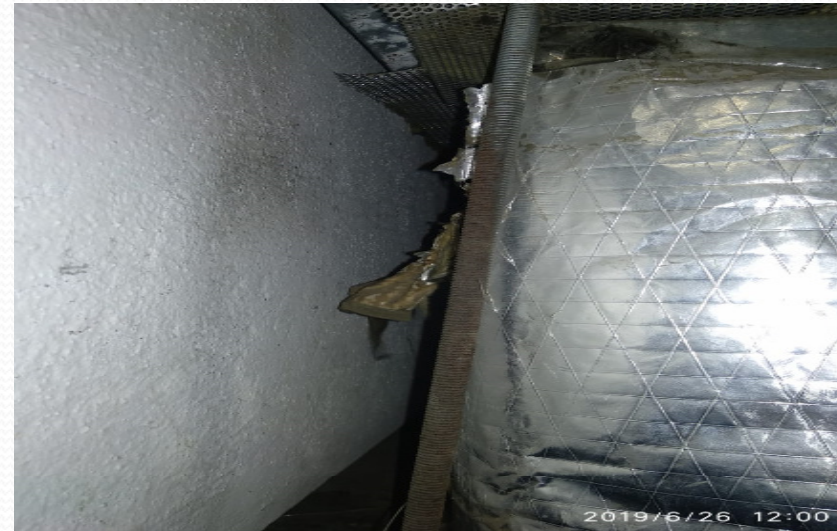
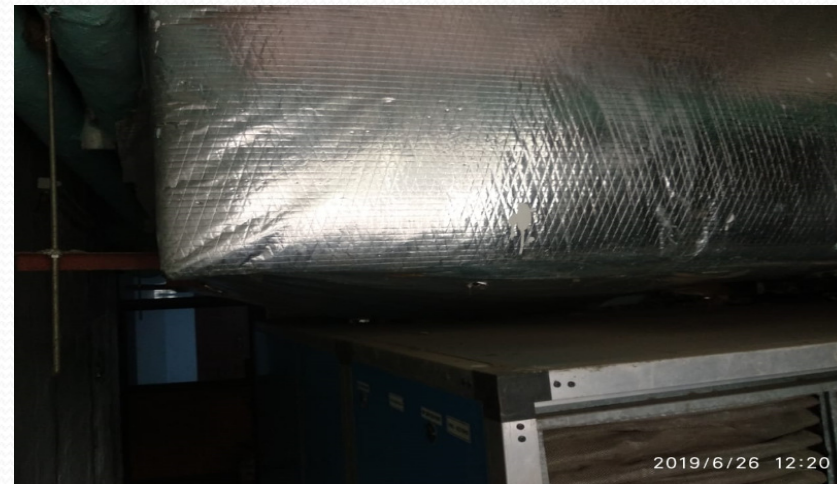
## Present condition of duct condition:

- As per Present site condition the supply air plenum has air leakage.

## Action to be taken:

- All leak to be patched up and has to be insulated properly but it is advised to replace the plenum itself for better lifetime.
- All unnecessary holes has to be closed.

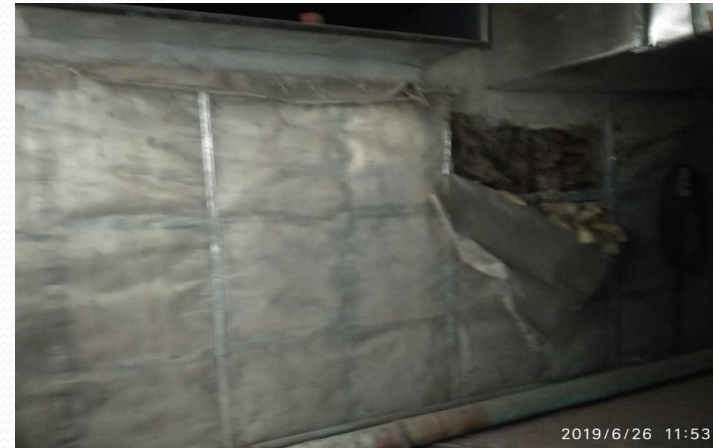
### **Present condition of AHU Room:**

- Wall Acoustic insulations are damaged.

### **Action to be taken:**

- Damaged wall acoustic insulation to be properly patched up.

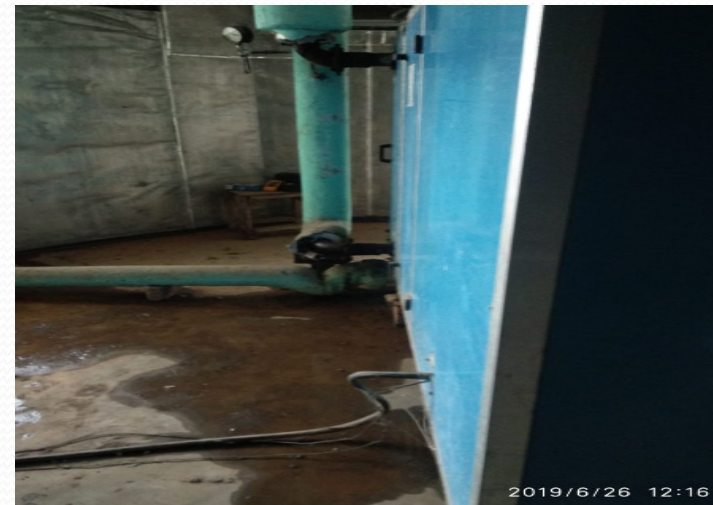
### **Present condition of AHU Piping:**

- Valve packages are not functioning properly.
- All valves and pipes has rusted.
- Drain pipe installed is damaged.

### **Action to be taken:**

- Valves packages has to be replaced.
- Drain pipes has to be replaced.

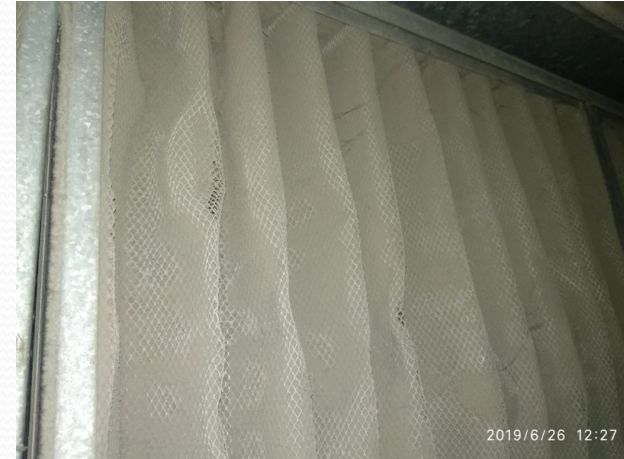
## Present condition of Ceiling Suspended unit:

- Ceiling suspended unit installed presently is unable to access which is being served to Auditorium stage.
- All filters are choked. We understand that there is no proper maintenance is involved since the installation.
- Performance of the equipment is also very less.

### Action to be taken:

- The equipment has to be replaced with new one and to be placed in a accessible place for proper maintenance.
- The equipment shall be replaced after rechecking the actual capacity as per heat load calculation.

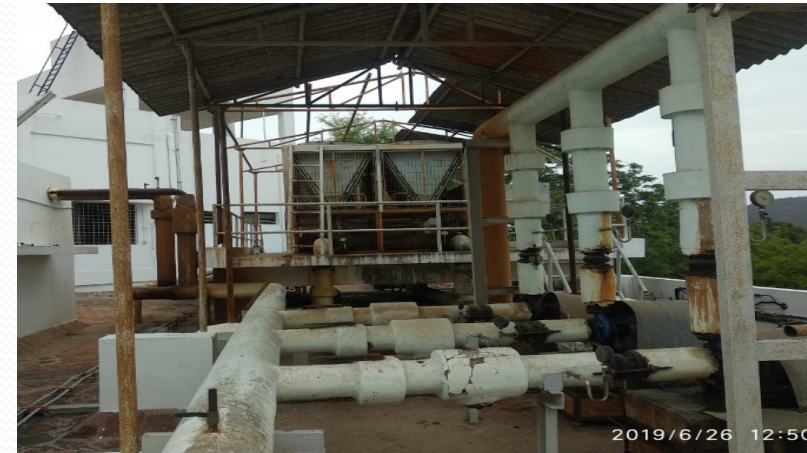
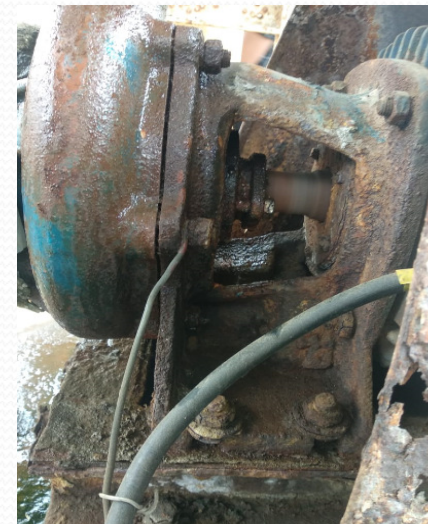
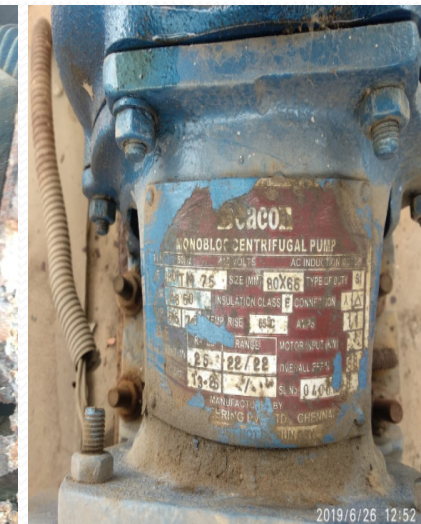
## Present condition of chilled water Pumps:

- Mechanical seal of one pump is Damaged and because of this water is leaking.
- All Pumps are rusted.
- Performance of the equipment is also very less.

## Action to be taken:

- Mechanical seal can be replace but it is advised to replace all pumps since they are corroded and there is no performance.

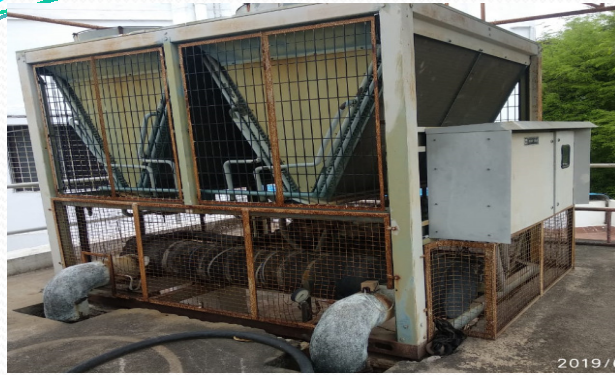
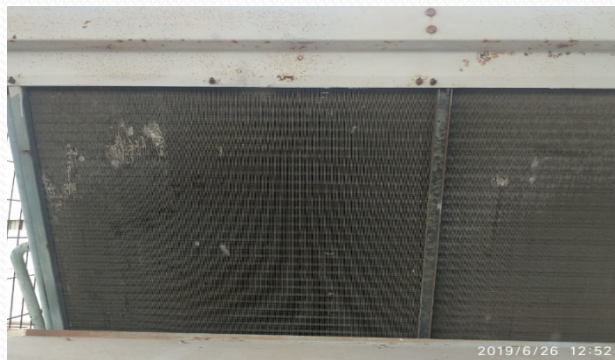
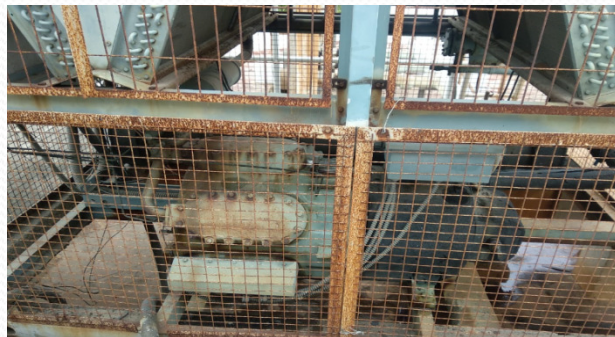
## Present condition of Air cooled Chiller:

- Both chiller Performance condition is very less and has inlet and outlet temperature of  $10.3^{\circ}\text{C}$  &  $12^{\circ}\text{C}$  respectively, instead of  $6^{\circ}\text{C}$  &  $11^{\circ}\text{C}$ .
- There is no efficiency in the present compressor and it is resulting in unnecessary power consumption.

## Action to be taken:

- It is advised to change both the chillers as per the actual capacity for better performance.

- Both the air cooled chiller has to be replaced for better performance The chiller performance period is maximum of 12-15 years with the regular maintenance. Since the maintenance is not regular the chiller performance is very poor. So, we need to replace with the new chillers.
- Chilled water pumps are rusted and leakages are there due to poor maintenance. Hence all primary pumps has to be replaced. If we required we can use existing pump as standby one after confirming the quality of the existing pump status.
- AHU to be replaced or at least chilled water coil has to be replaced since all AHU Cooling coil tubes are covered with Scale (fungus).
- Ceiling suspended unit serving for stage has to be relocated and ducting has to be replaced.
- Wall acoustics patch up has to be done.
- AHU Plenum to be replaced.
